Members: Diana Khairallah University: IFSTTAR

RA7 Transport Infrastructure

## Monitoring of railway structure with bituminous underlayment

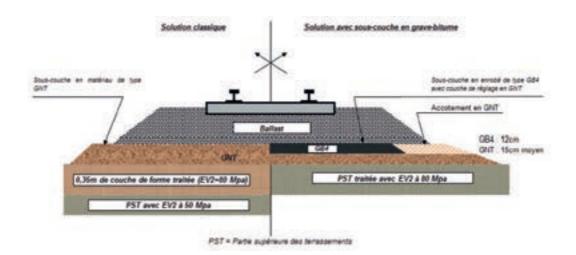
In order to study the dynamic responses of these different structures and understand the effect of the different layers on the dynamic response, and for the first time, four sections were instrumented (three with asphalt concrete and one on a standard granular structure) using, among others, accelerometers, strain gauges, temperature probes, etc. More than 100 sensors were installed on the structure in different positions and depths. The acquisition of the data was made during the speed up test phase under controlled conditions with the same train passing with speeds going up from 160 to 352 km/h. Afterwards, measurements of all the sensors were treated under actual traffic. The BPL lane was subjected to commercial traffic
